Limited Visual Dam Safety Inspection Summary Report

HI - 00123

Puu Pulehu Reservoir

May 2006

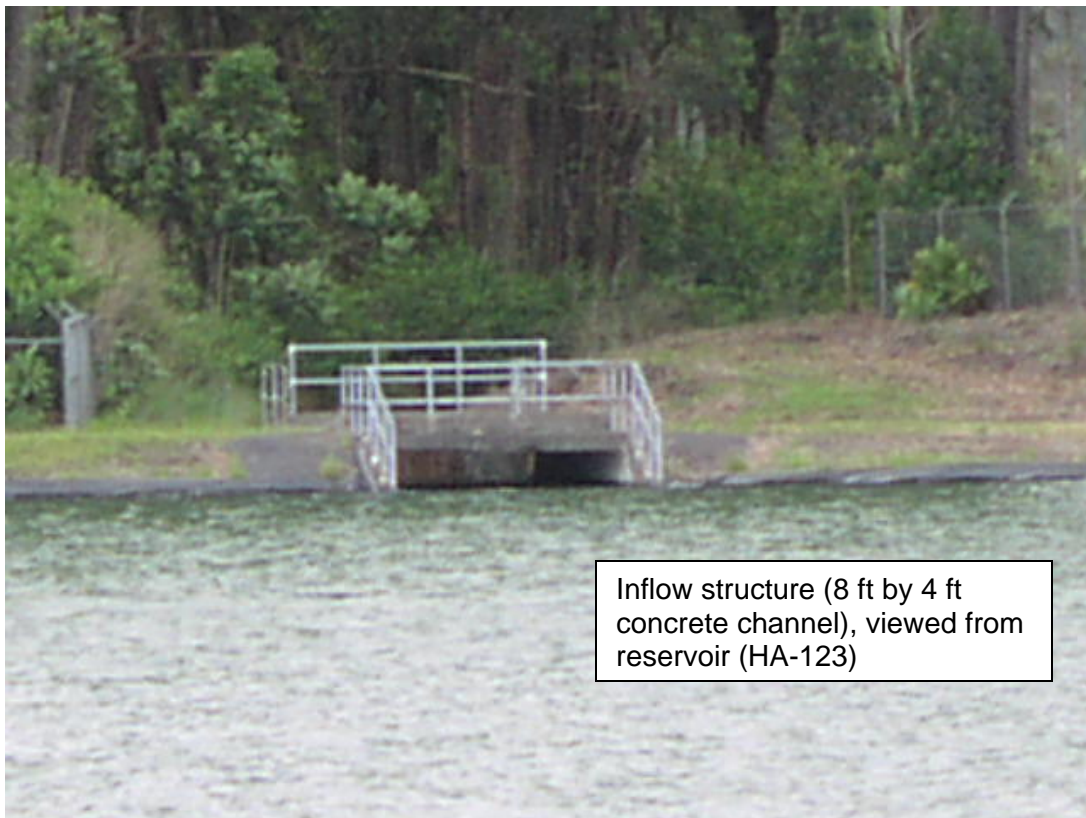
Inflow structure (8 ft by 4 ft
concrete channel), viewed from
reservoir (HA-123)

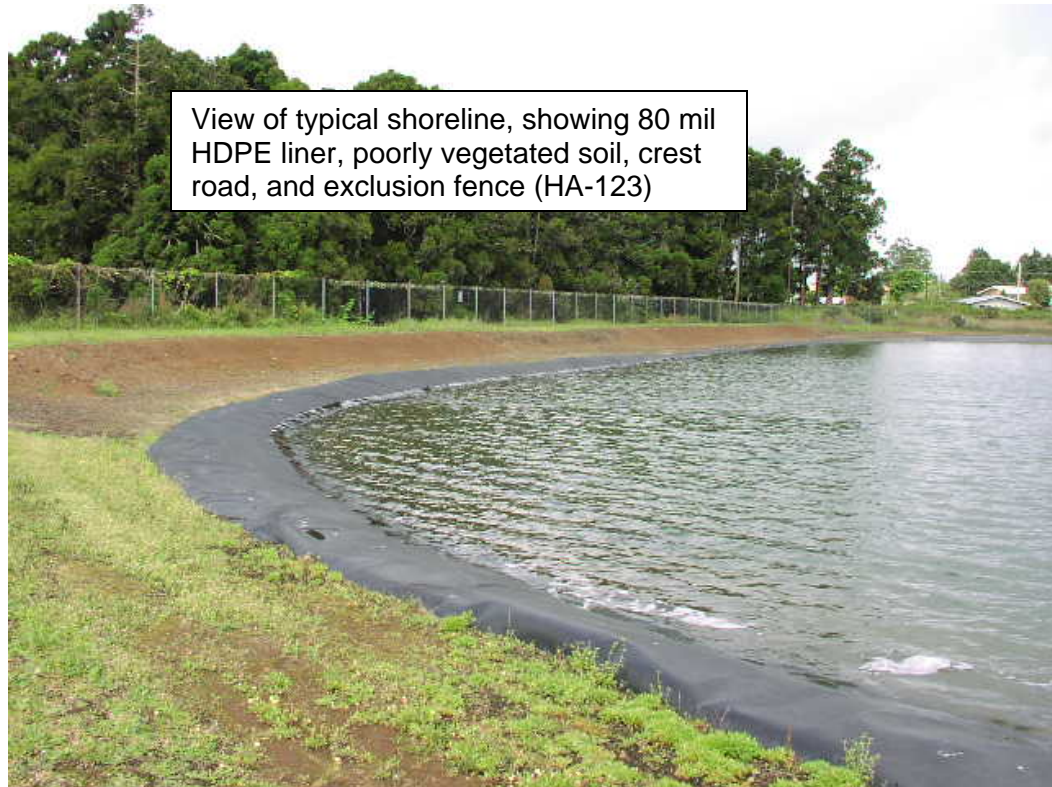
View of typical shoreline, showing 80 mil HDPE liner, poorly vegetated soil, crest road, and exclusion fence (HA-123)

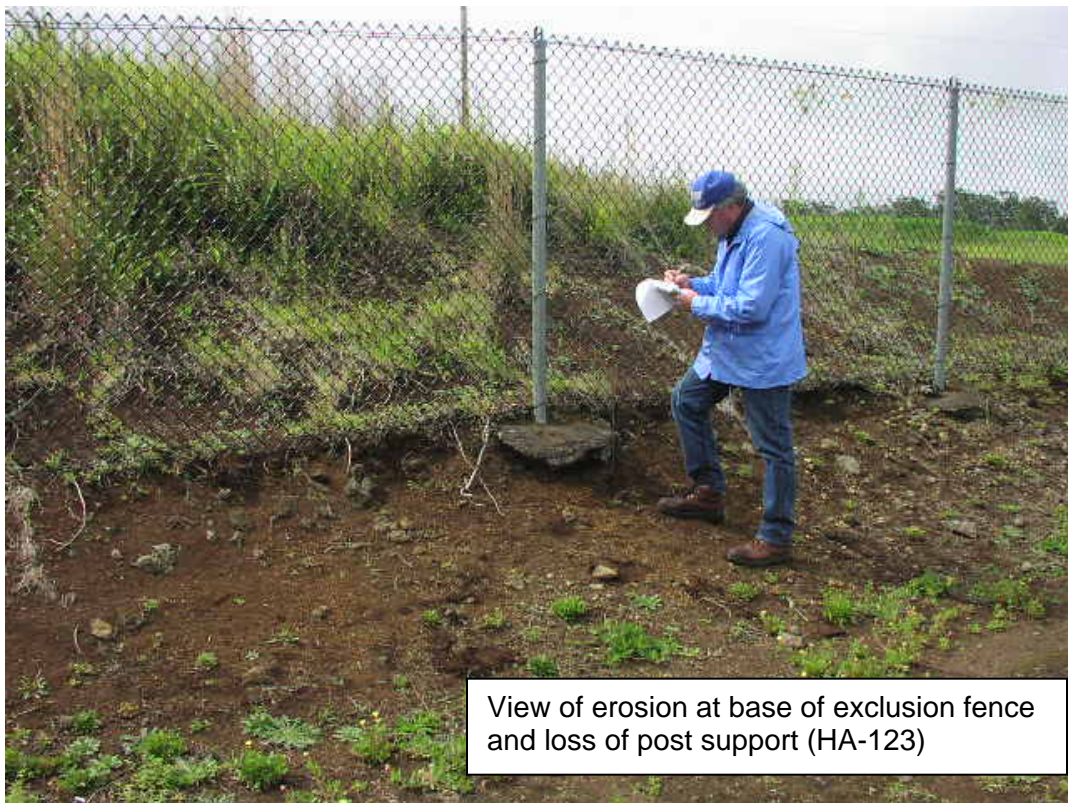
Along much of the fence, unvegetated soil has eroded by rainfall from beneath the fence and the base of many posts, undermining their support (see photos). Smaller animals may access the reservoir beneath the fence in these areas. Steep, smoothly lined slopes inside the reservoir present a drowning hazard to any person or animal that falls in.

View of erosion at base of exclusion fence and loss of post support (HA-123)
